PART VII IN A SERIES

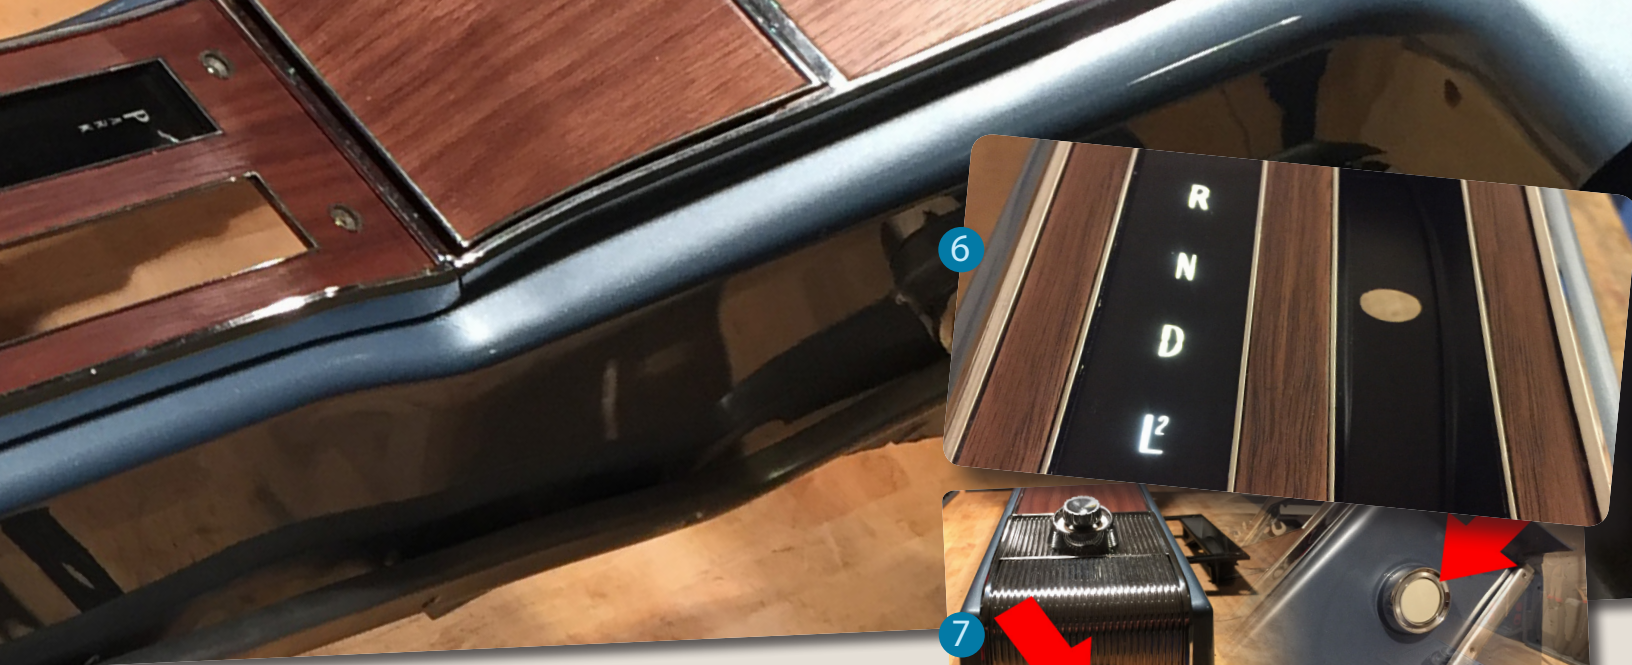
attached to the light housing, the cables are best connected with clamps. Before the light socket is reinstalled, it makes sense to check the result with a 12V battery (Fig 6)

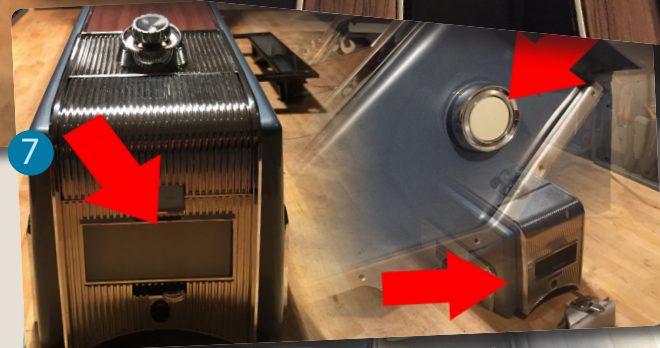
I have changed the whole interior lighting to LED and replaced all the courtesy light lenses with new ones. You can find them easily as a set on ebay and are very easy to install (Fig 7).

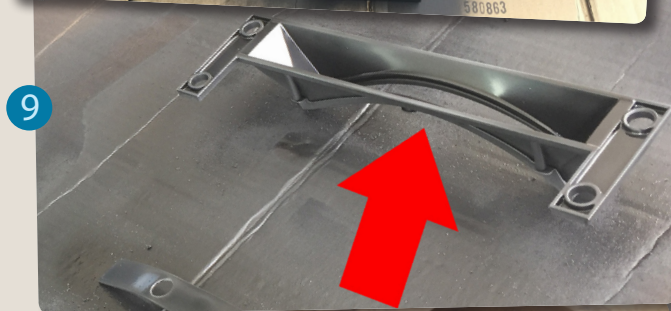
In the rear vents, I have renewed the black mat color with heat resistant matt synthetic resin paint, as well as various parts that were originally unpainted. In particular, the inner area of the shifter (Fig 6) has a much more noble effect on black and in this way, visually it forms a clear unit with the shifter indicator. With the same matt varnish, I painted the front of the original radio, the AC and the inside of the console compartment including the lid (Fig. 8). This way, everything works beautifully coordinated. At this point, it seemed to me useful to renew the gear cover because the plastic was damaged. I used a black approx. 1mm thick plastic sheet I cut in the same length and width as the original and drilled the hole for the shifter exactly the same diameter and location as the original. After that, return it to the semicircular guide of the part (Fig 9) Since I had previously restored the wood veneers of the center console (see also article part 2), I also decided to replace the original plastic knob and make a new one in the same wood as I used for the veneer (Fig 10) which I think, makes it much classier!
